EXPERIMENTAL STUDY UNDER GROUND-HOLD CONDITIONS OF SEVERAL INSULATION SYSTEMS FOR LIQUID-HYDROGEN FUEL TANKS OF LAUNCH VEHICLES

by Porter J. Perkins, Jr.

Lewis Research Center
Cleveland, Ohio

NATIONAL AERONAUTICS AND SPACE ADMINISTRATION • WASHINGTON, D. C. • MARCH 1965

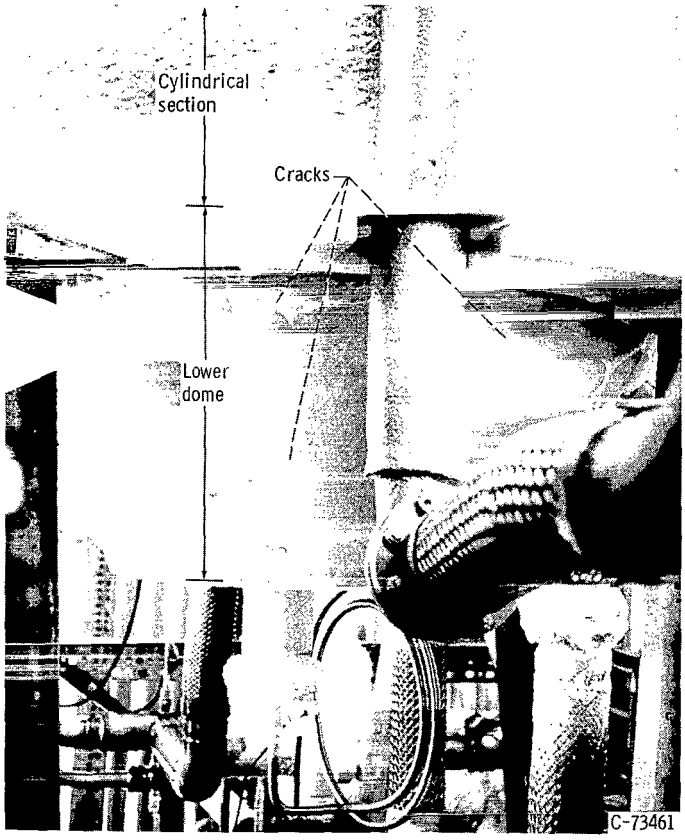
Following the first loading of tank 1 with liquid hydrogen, inspection of the outer surfaces revealed cracks in the corkboard, particularly in the bottom dome area, as shown in figure 12, and in the Mylar seal on the cylindrical surfaces. Later inspection showed separation of the corkboard from the walls of the tank. In fact, when the insulation was completely removed from the tank at the completion of testing, about 50 percent of the surface area was found to be unbonded. Loss of insulating effect occurs when air enters the insulation,

particularly if it reaches the tank walls and condenses. This is apparently what occurred, since blisters in the Mylar surface in several areas indicated failures in the seal, which allowed air eventually to reach the tank surface. During warmup after a test, expansion of the liquid air broke the bond between the corkboard and the tank. Sharp cracking sounds heard during the boiloff period could have been caused by this action taking place. Other investigators (ref. 5) have observed similar results with corkboard on tanks containing liquid hydrogen.

The failure of the corkboard insulation in these tests may have been the result of the inadequacy of techniques for bonding and sealing to complicated surface contours (top and bottom domes) and around attachments to the tank. Application techniques, which were successful as described in reference 3 and followed here, were employed in reference 3 only on the straight cylindrical surface of a small tank. Fabrication problems for curved surfaces and joints were not sufficiently resolved in the limited scope of this investigation to produce a completely successful system.

Figure 12. - Cracks in corkboard insulation (area sealed with lacquer on lower dome) following cooldown of tank with liquid hydrogen.
